*Shijiazhuang CAPT Full Standard  
Range of Steel TB Taper  
Bushings – A **New** Choice  
for Industrial Safety!*

**SHIJIAZHUANG CAPT POWER TRANSMISSION CO., LTD.**

**C45 Steel High-Strength TB Taper Bushings – Your Safe Choice!**

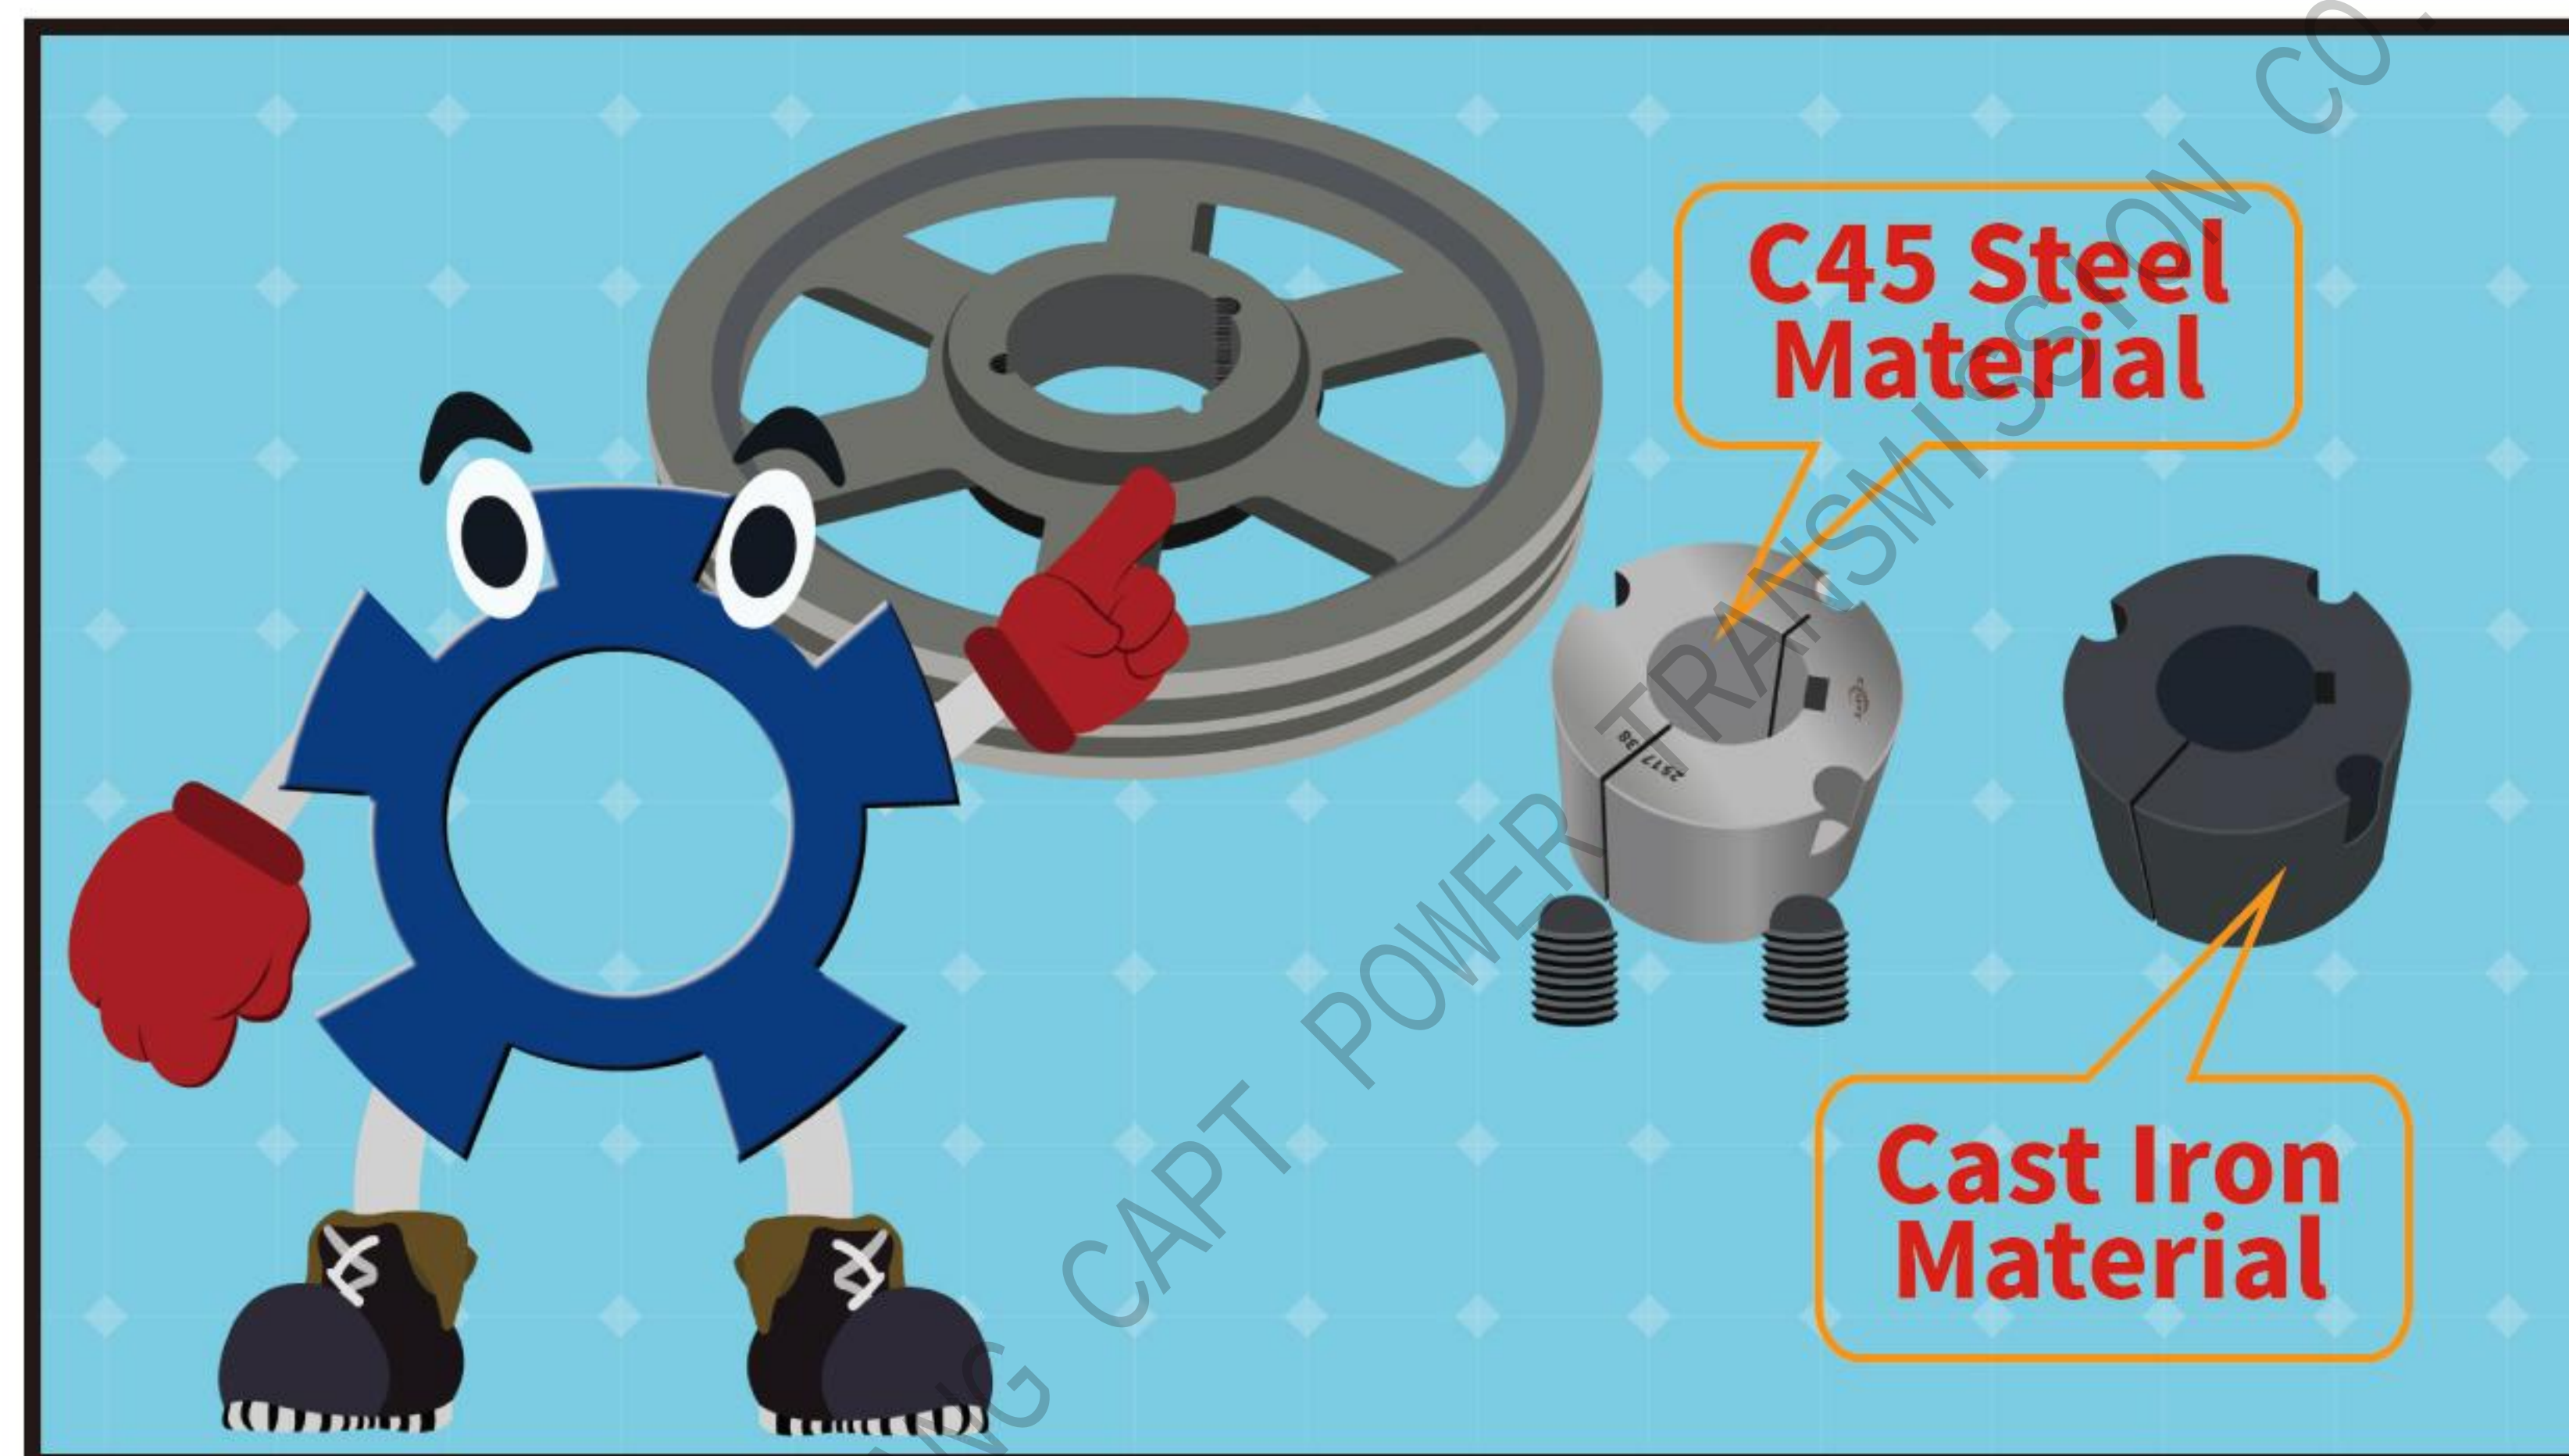
①TB taper bushings come in two types: high-strength and low-strength materials.

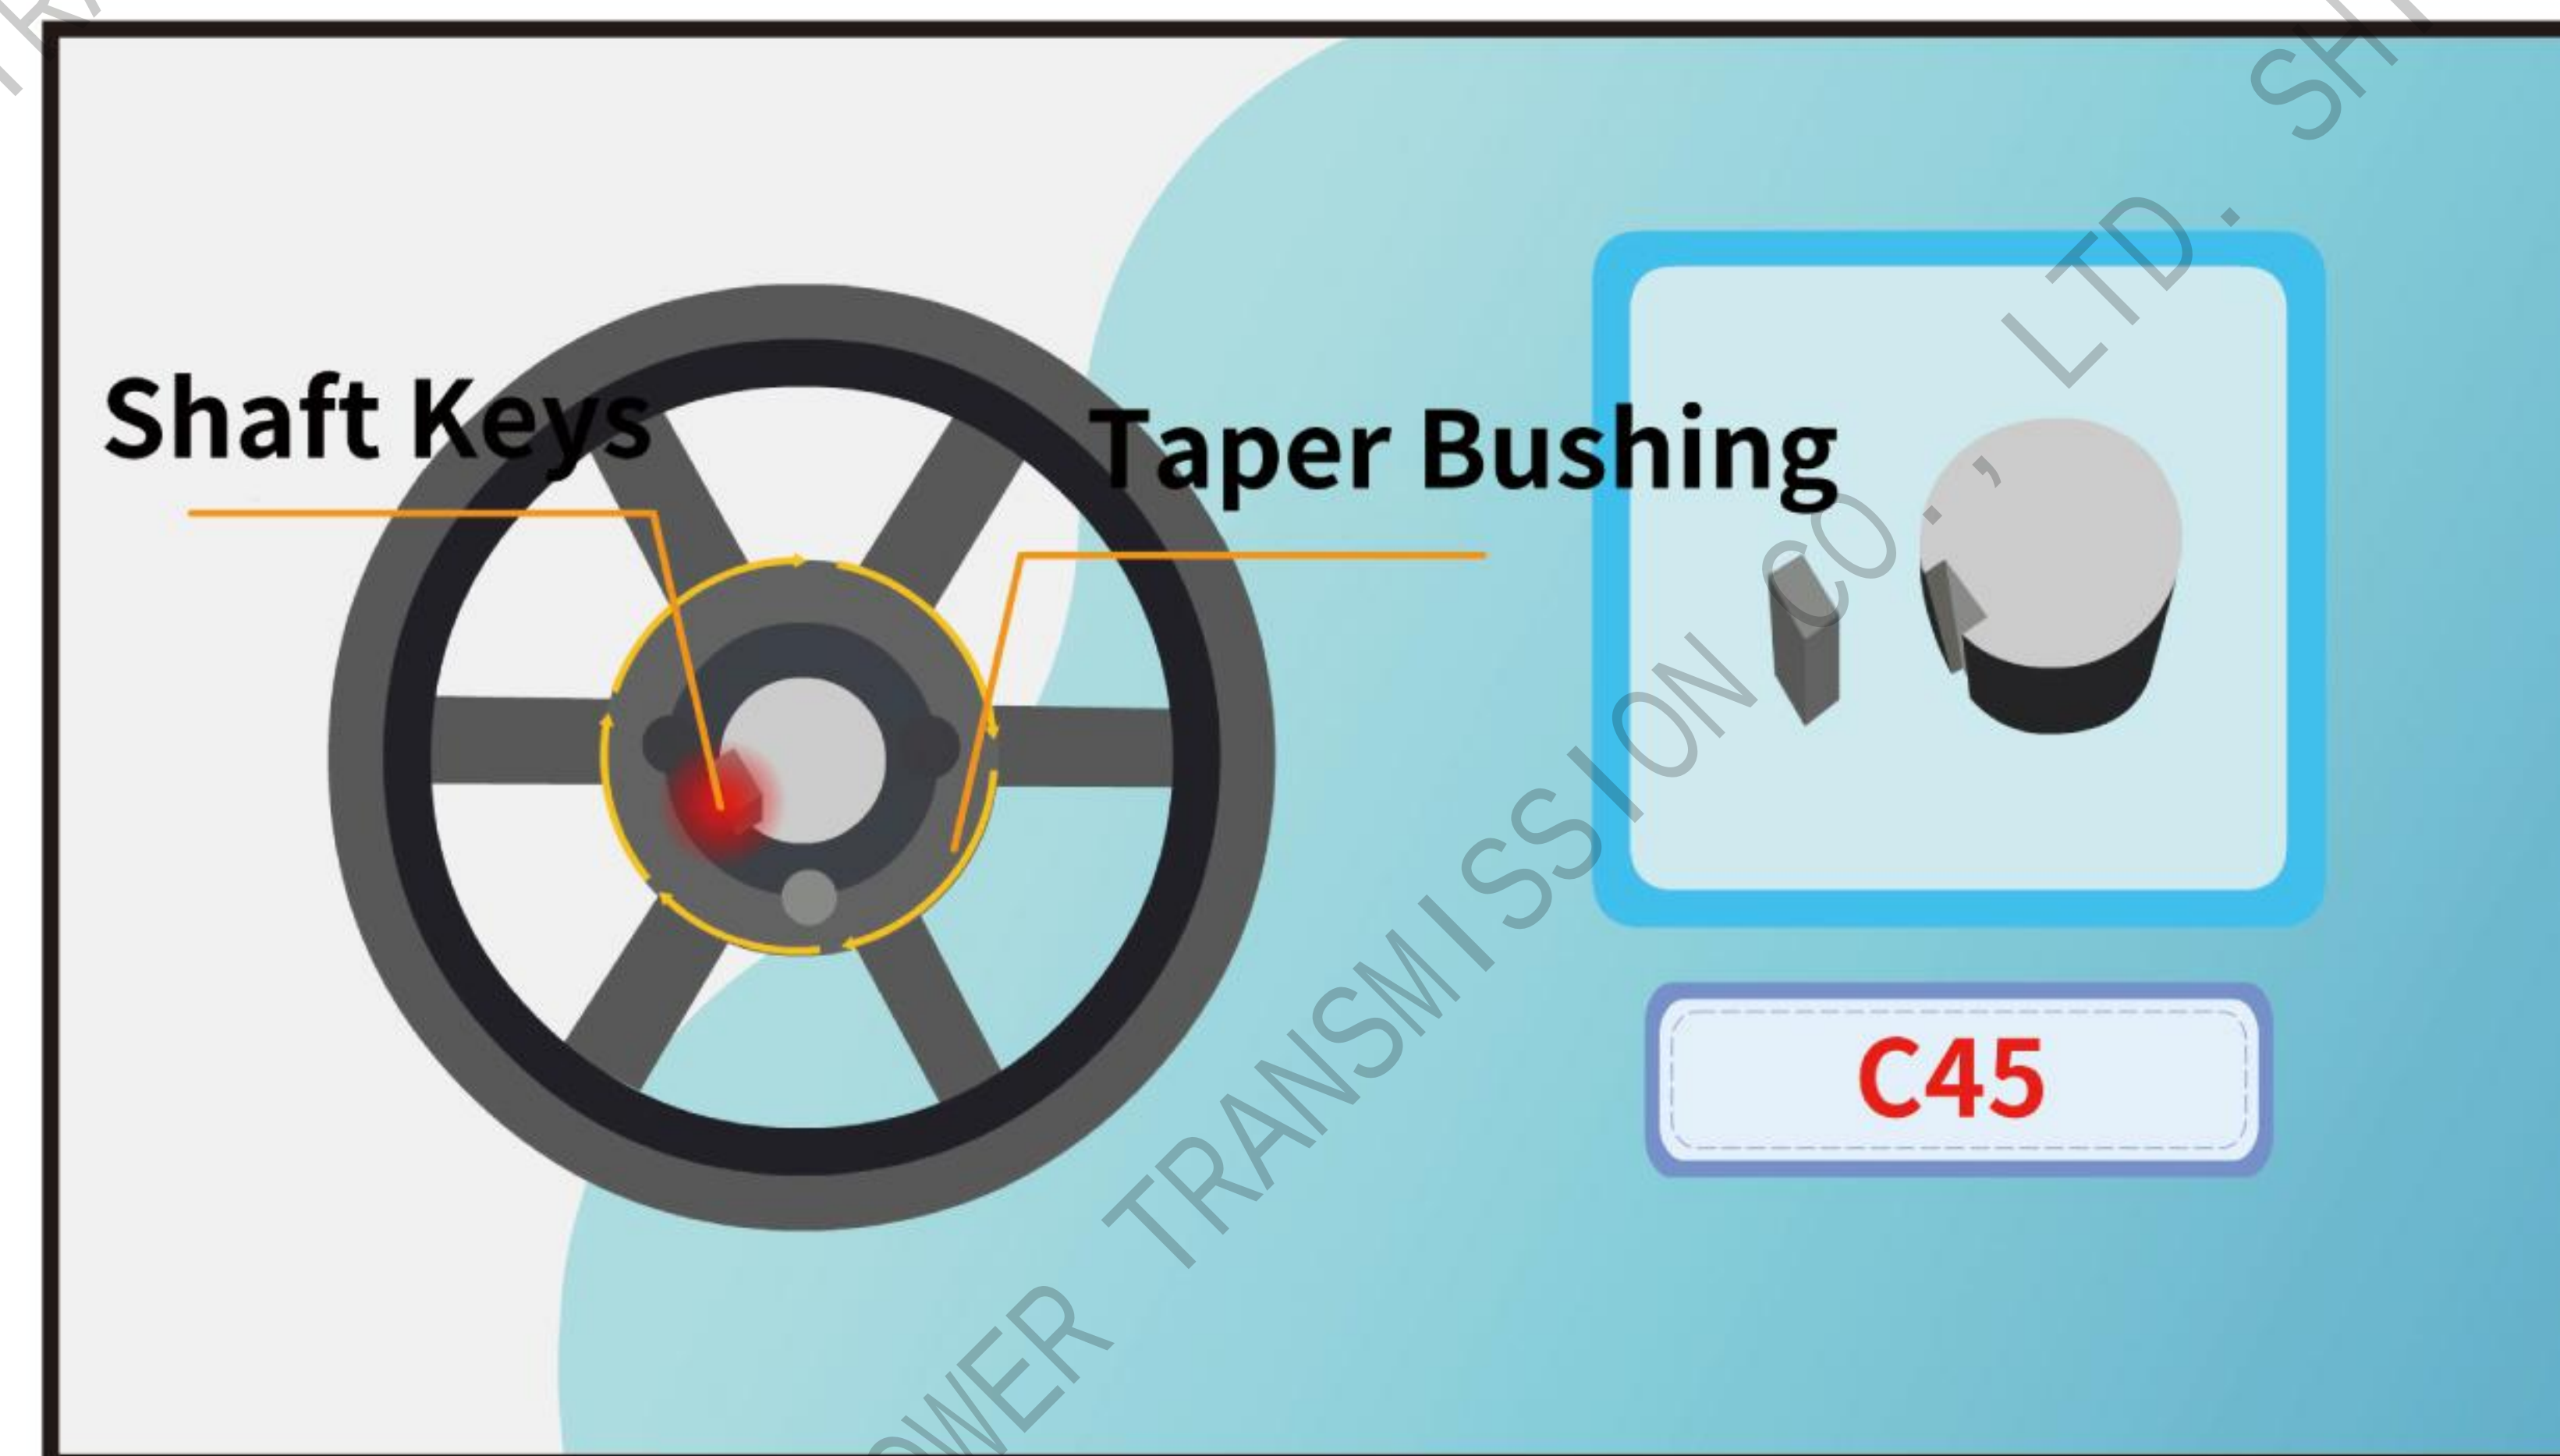
⑧ The tensile strength of C45 steel shaft keys is higher than that of cast iron bushings.

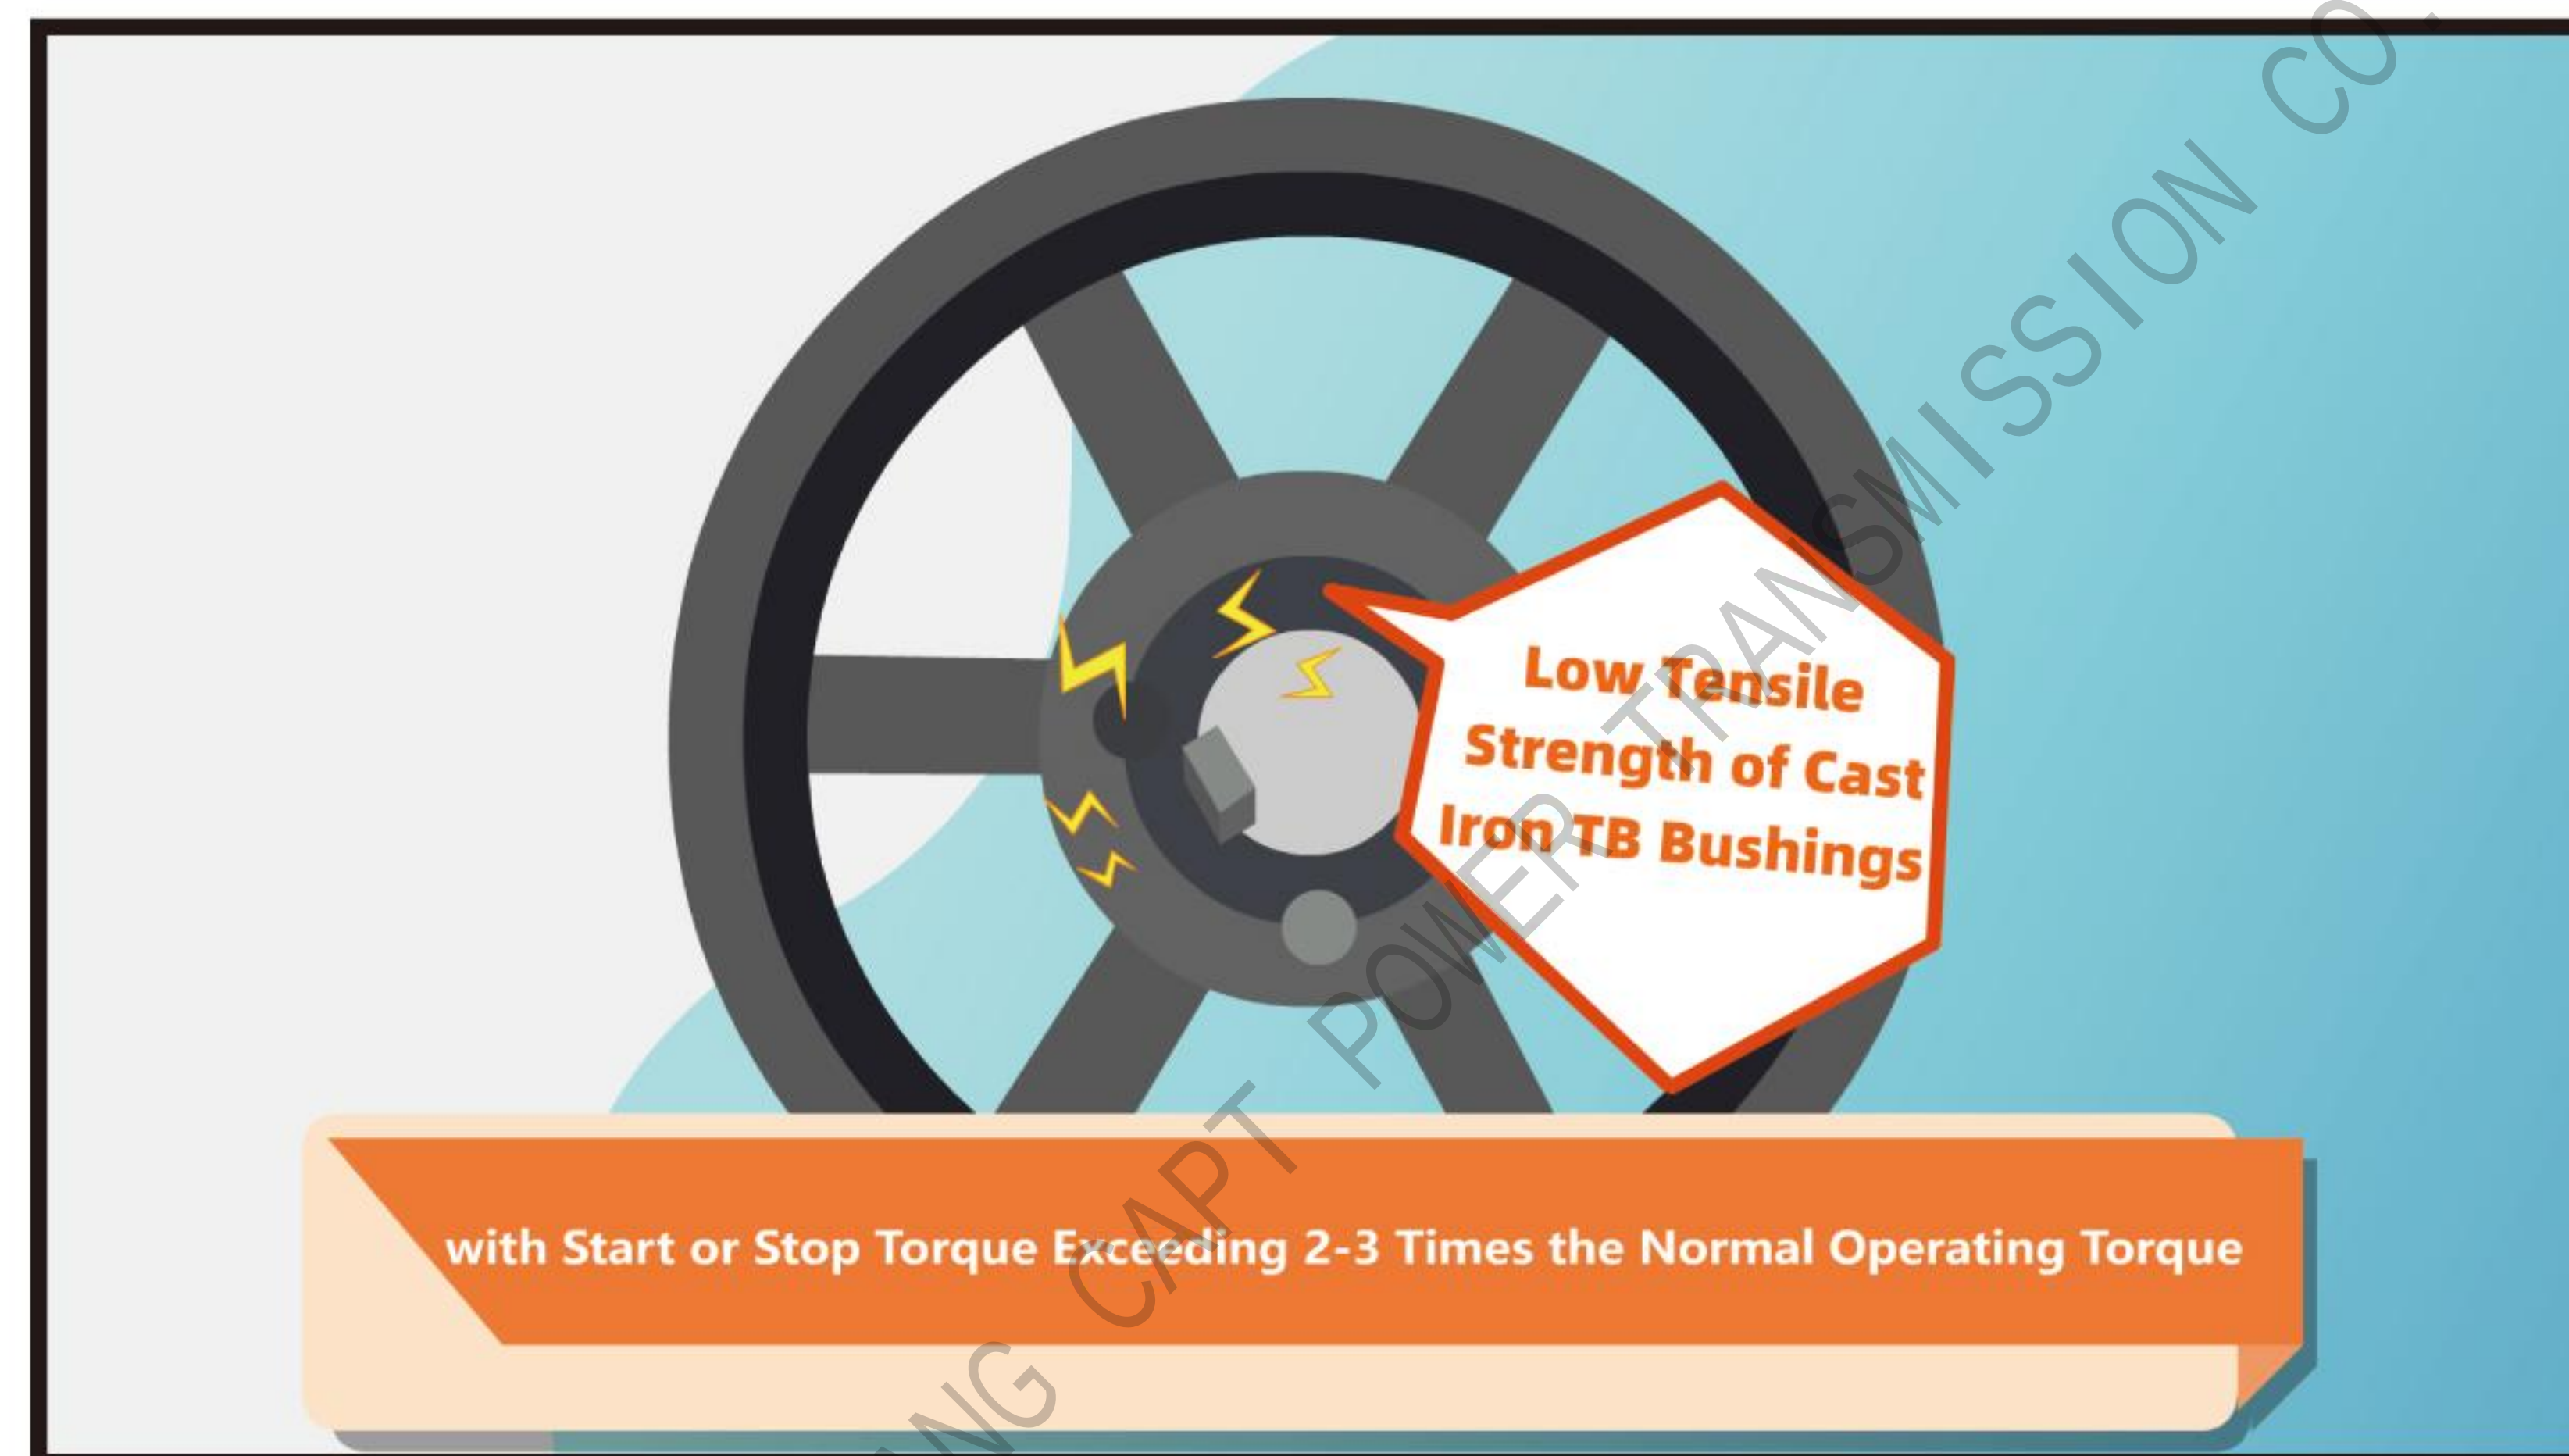
⑨ During operation, strong torque impacts the weak keyway positions.
